## OLD CONCRETE BUILDING PATHOLOGY CASE STUDY

*The present case study concerns an old reinforced concrete building, whose design dates from 1956. This is a building with an area of  $(38 \times 10) \text{ m}^2$ , consisting of 7 floors, and containing a lower partially buried floor. At present the building is being subjected to an intervention for structural reinforcement and functional requalification to adapt to new use.*

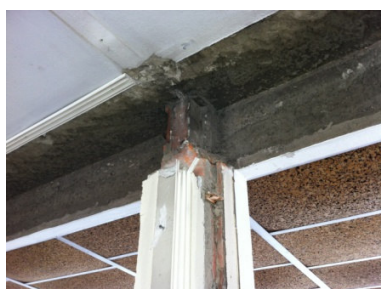
walls. Another aspect that weakened the strength of the pillars was the reduction in their section in the upper zone (zone connecting the slab) for placement of windows blinds (Fig. 3).

Figure 3. Example of concrete column in 7th floor, after removing the windows blinds.

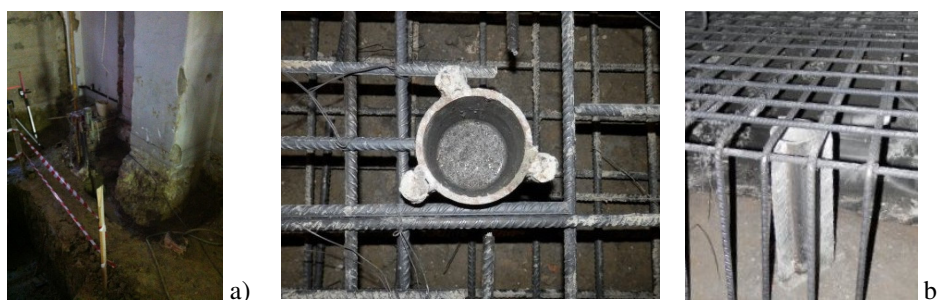
During the excavation, a lack of foundation beams, which were represented in the existing structural design, was identified. One of the concrete columns was also missing. The foundations consisted mainly of insufficient and shallow dimension sabots. No foundation beams, no structural lock beams existed. Also, no elements to minimize the access of ground water to the basement were present. In an attempt to solve this problem, a concrete wall that connected the foundations of the main façade, which borders the public highway, was built. The solution adopted in this intervention was the implementation of a general mat foundation with two mesh armours, linked to micro-pegs performed at the base of the existing pillars. Micro pegs ensure a deeper foundation for the building and deeper mat foundation [4]. The loads transfer to the ground is also more uniformed.

Figure 4. a) No foundation column; b) Micro pegs and mat foundation armour.

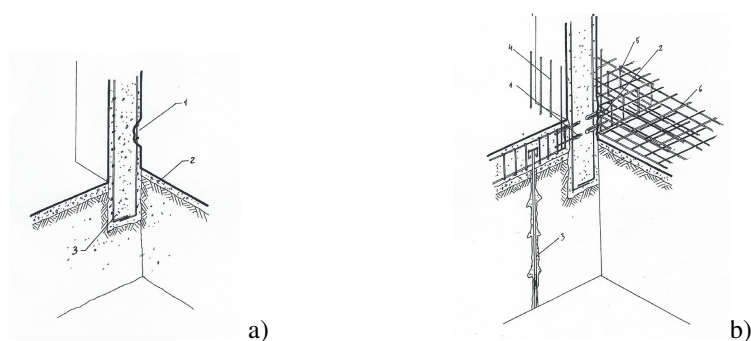
Figure 5. a) No foundation column; b) Connection of the beams to the column

Since the aim was to increase the cross-section of the columns, mat foundation rods were left that allowed the connection to the reinforcement of the subjacent columns. To ensure a good locking at the base of the pillars, mat foundation beams connecting the columns were incorporated. The connection of these beams to the column was ensured by fixing the rods with chemical anchors.

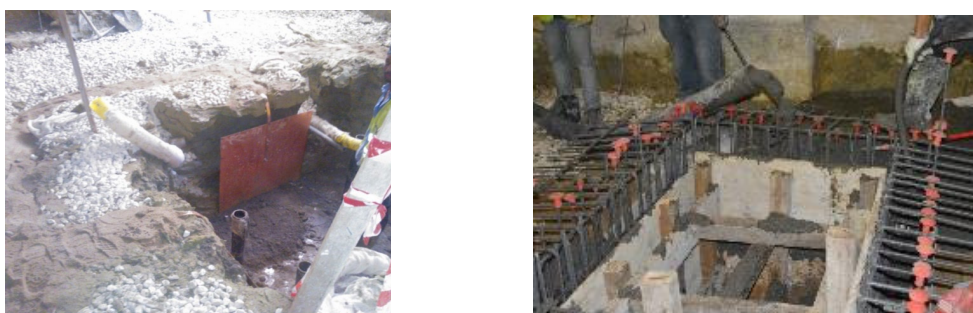
Figure 6. Phases of the execution of the pumping pit

Along with drilling holes for micro pegs, manual excavation of the drainage network pumping pit for sewage and storm water was carried out. The solution adopted allowed the initially planned piers to be dispensed, thus avoiding significant structural settlements.

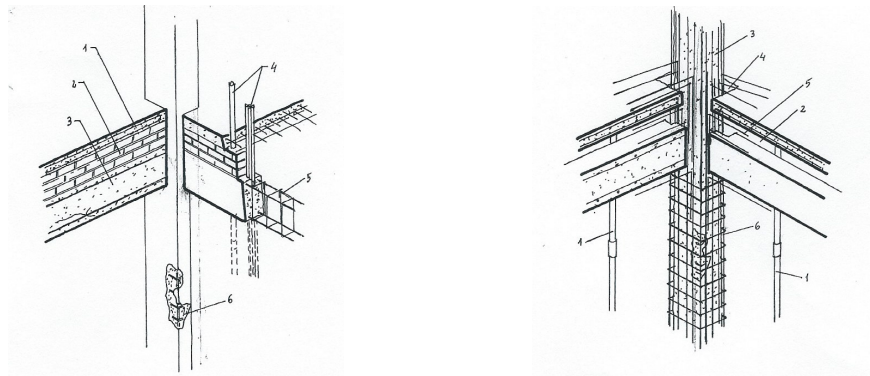
The beams cross-section was also lower than expected, since they were lined with brick, and the straps were too much spaced and built with smooth surface small diameter rods (smooth

reinforcement rods 6 mm in diameter and 15 cm apart straps). The beams were continually crossed by several infrastructures such as electrical wiring, networks of water, gas, etc.

Figure 7. Anomalies in concrete columns and placement of reinforcement rods.

After removing the plaster and other coatings of the vertical structural elements, an exhaustive survey was carried out, to assess the location and size of the existing columns and beams. This action allowed the review of structures and architecture design, since the preliminary survey work carried out in the structure detected substantial differences from the original design. The columns, in addition to small cross-section, evidenced the existence of voids and reinforcing steel corrosion, with concrete detachment of the edges. The columns steel armour presented insufficient cross-section and smooth surface. The strengthening of the columns was carried out by concrete jacketing [5]. The columns were enveloped with a new armour and then a new layer of concrete was applied.. Special care was taken to scarify the original column surface to increase adhesion of the new concrete to the existing concrete, and also to let waiting steel rods for later connection to the new slabs, guaranteeing the continuity of the lining on the upper floors (see Fig.7).

The beams were reinforced by a process identical to the pillars, i.e. placement of new reinforcement and filling with concrete. During this process, the slabs were properly anchored and the surface roughness of all the elements to be strengthened was guaranteed.

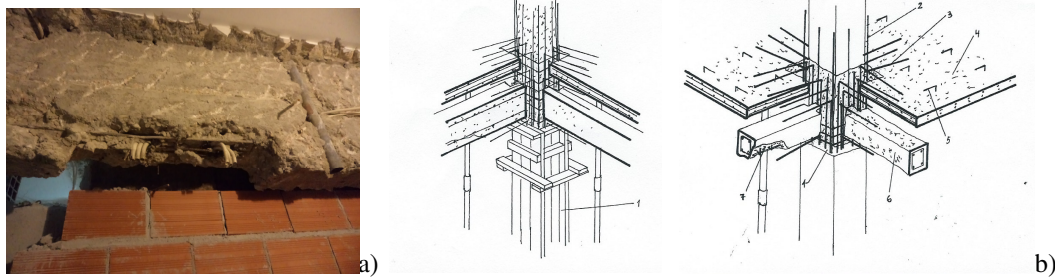
Figure 8. a) Beam crossing; b) Column reinforcement continuity

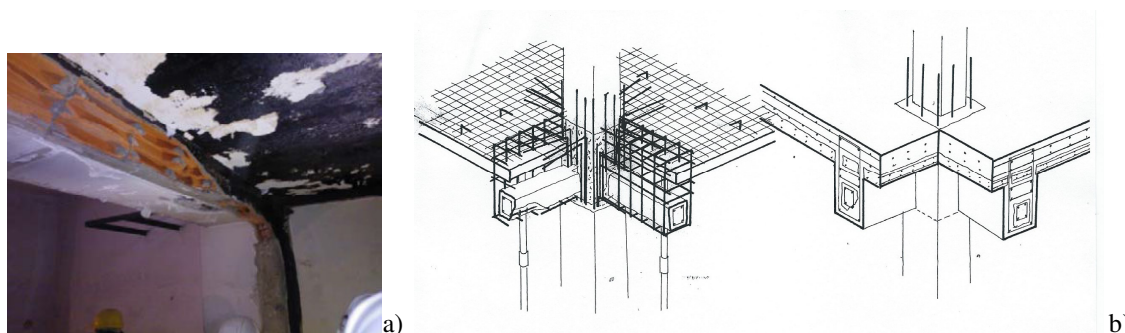
In some slabs, besides the small thickness and armour deficit, there was the additional problem of not being connected to the beams, but supported on the beams through bricks.

Figure 9. a) Beams after capping removal; b) reinforcement armour and concrete casting

To ensure the monolithic connection between the slab and the beams, the support bricks were removed, and the beam height was increased to connect to the new slab. To improve the adhesion of the new slab to the former one connectors consisting of bent rods have been placed. In order to avoid infrastructure crossing of the beams, new openings were created in the slabs, properly positioned for passing *coretes*.
